Re: May 2014 Monthly Progress Report
Administrative Settlement Agreement and Order on Consent for Removal Action
U.S. EPA Region 10 Docket No. CERCLA 10-2009-0255
Gasco Sediments Site within the Portland Harbor Superfund Site

Attachment A Monthly Visual Monitoring Report for Pilot Cap Vicinity

Visual Observations Log Form

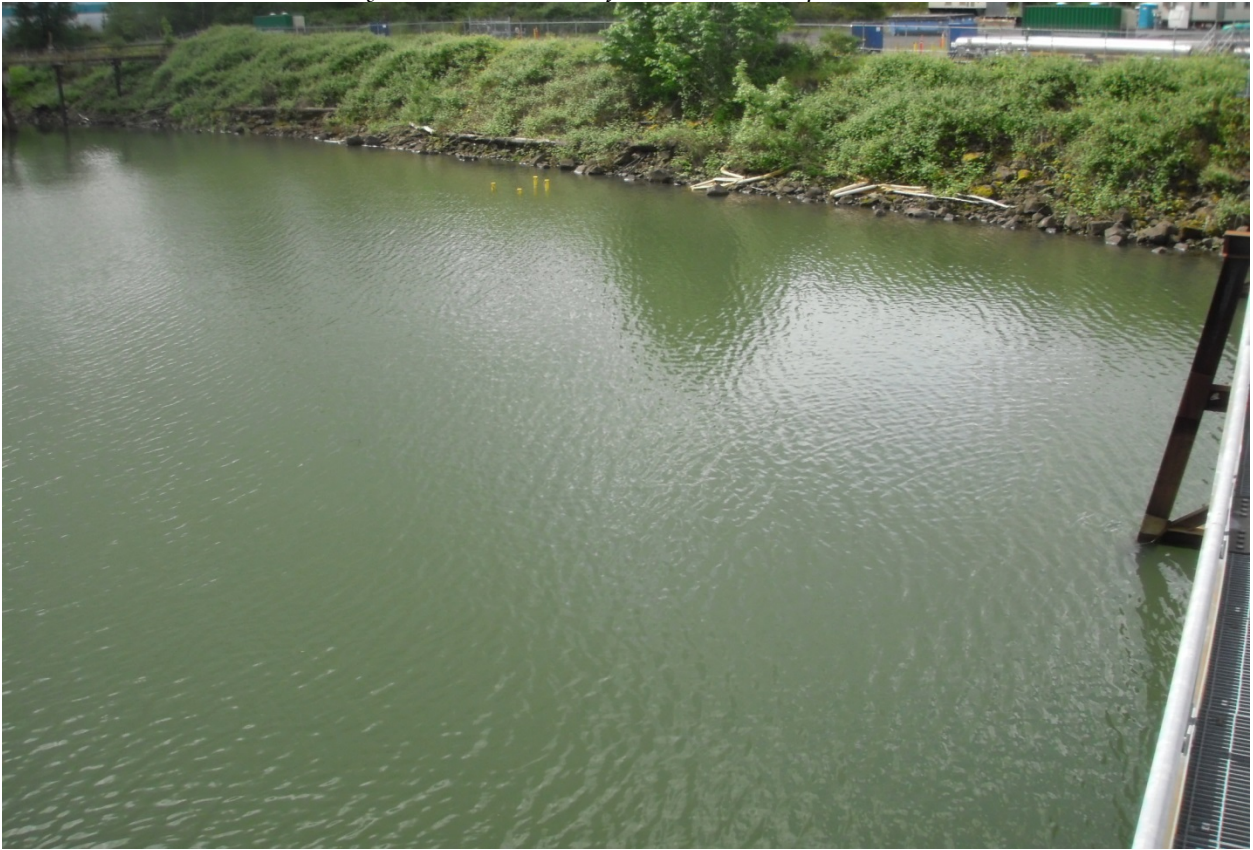
Observations of Erosion/Deposition: No erosion/deposition is evident along the shoreline. The shoreward extent of the cap was not visible due to high river water elevation and the extents of the organoclay mat material were also submerged. (Photo 1).

Photo 1 — *River level currently above the extents of the sediment cap (5/19/14):*

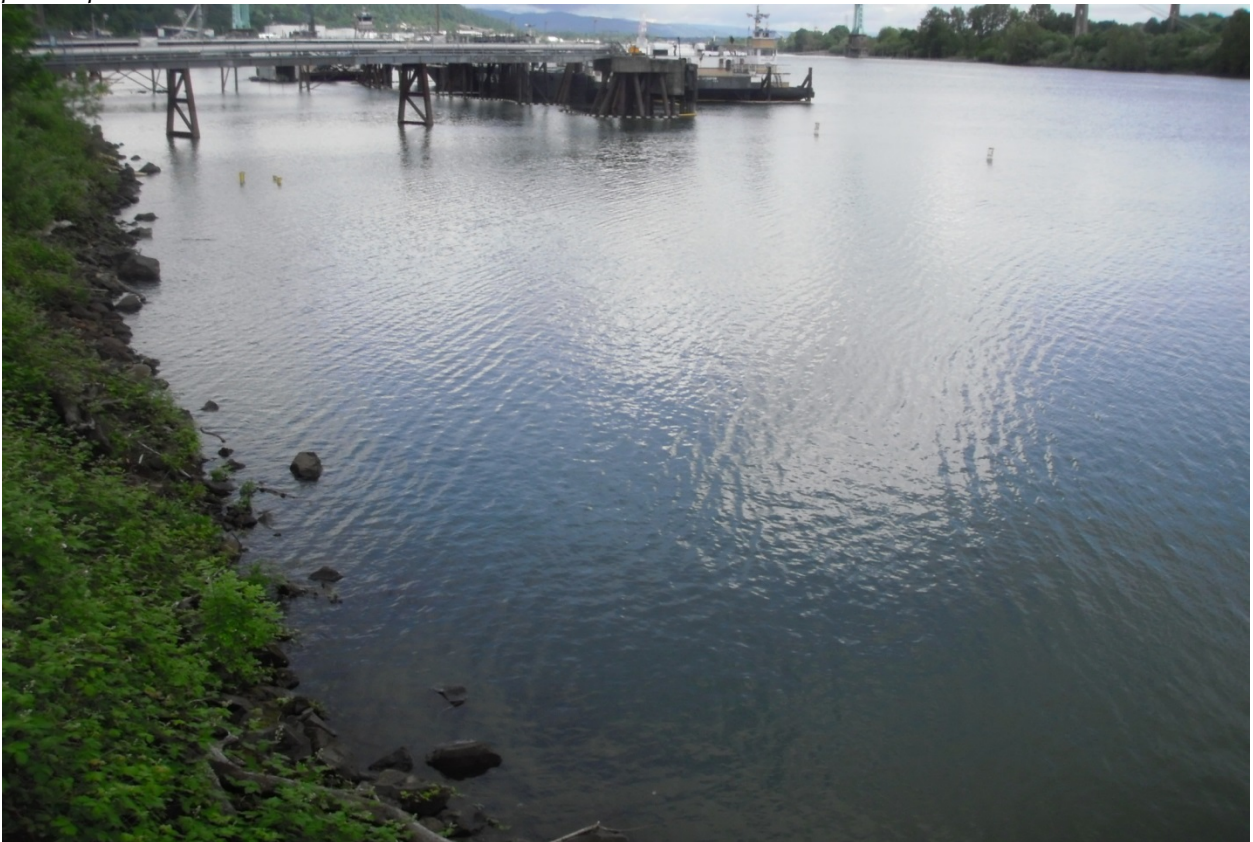
Observations of Long-term Controls (i.e., oil booms, organo-clay mat, etc.) During the observation, the Fuel and Marine Marketing (FAMM) containment boom was placed around a barge moored at the FAMM ship dock. Buoys that identify the cap area to mariners are in place as installed. The position of the FAMM oil boom, warning buoys, and a general overview of the site shoreline is shown in Photo 2.

Photo 2 — *FAMM oil boom shown around barge and the mariner warning buoys in place across the pilot cap area (5/19/14):*

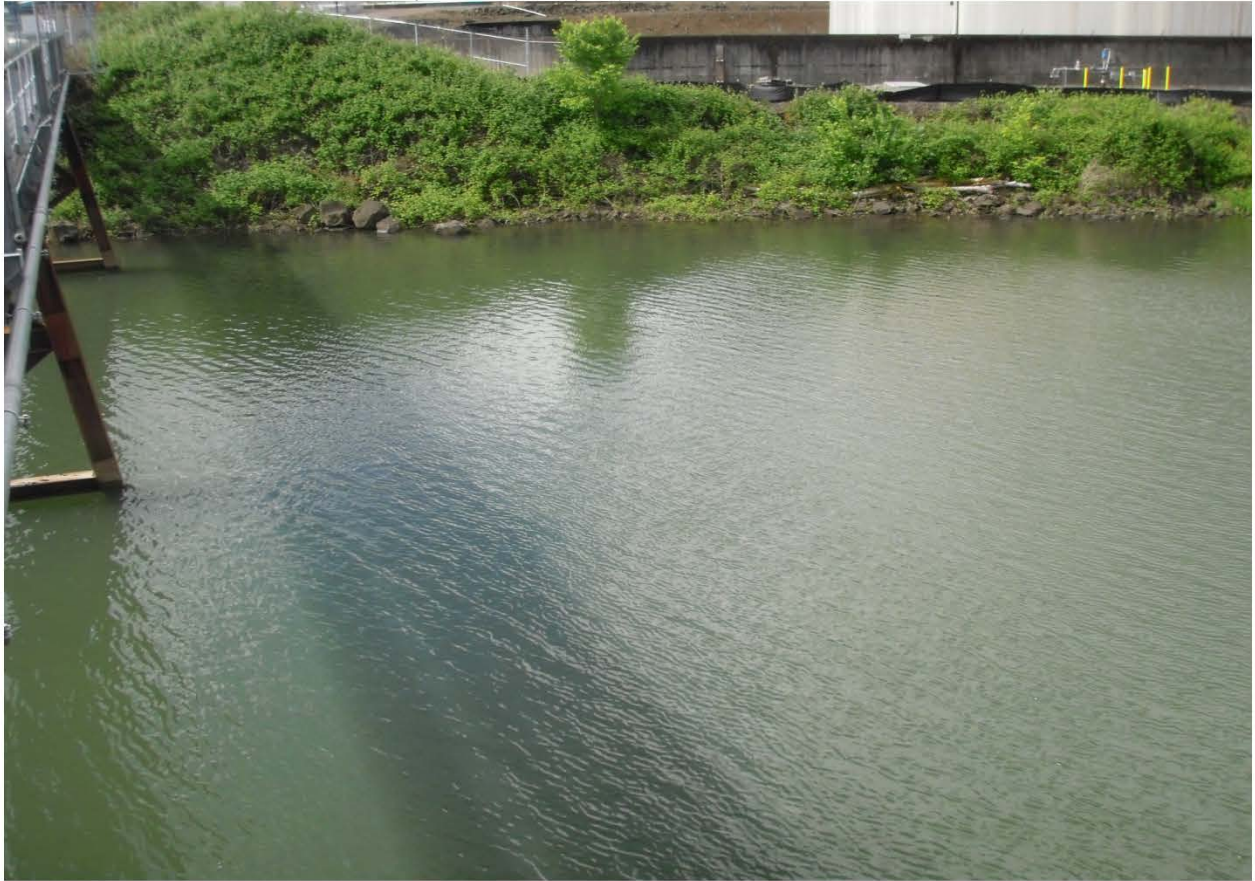
Other Comments: No sheen is evident in or around the cap area. Photo 3 shows the water surface and shoreline immediately downriver of the sediment cap.

Photo 3 — *Conditions immediately downriver of cap area (5/19/14):*
